## Evaluation of Bridge Components Salvaged from Historic Route 66 in California

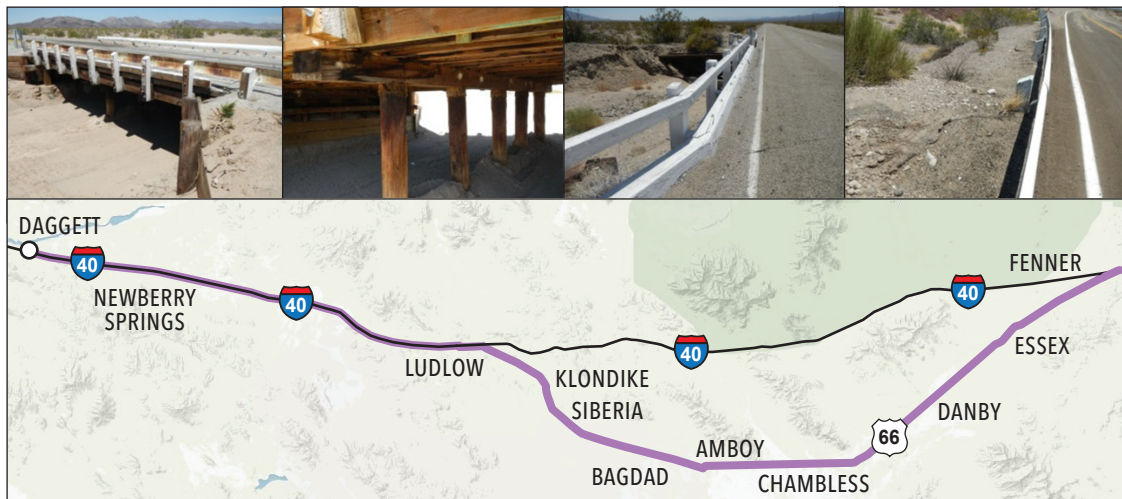
Original design features of the timber bridges located along historic California Route 66 (highlighted in purple) include standard 19-ft simple spans, timber pile/cap intermediate supports, timber bridge railing and curb system, and a flexible metal approach railing mounted on timber posts.
